FRENCH RIVER BASIN,
DUDLEY, MASSACHUSETTS.

LARNER POND DAM
(MA 00111),

**PHASE I INSPECTION REPORT
NATIONAL DAM INSPECTION PROGRAM**

AUGUST, 1978

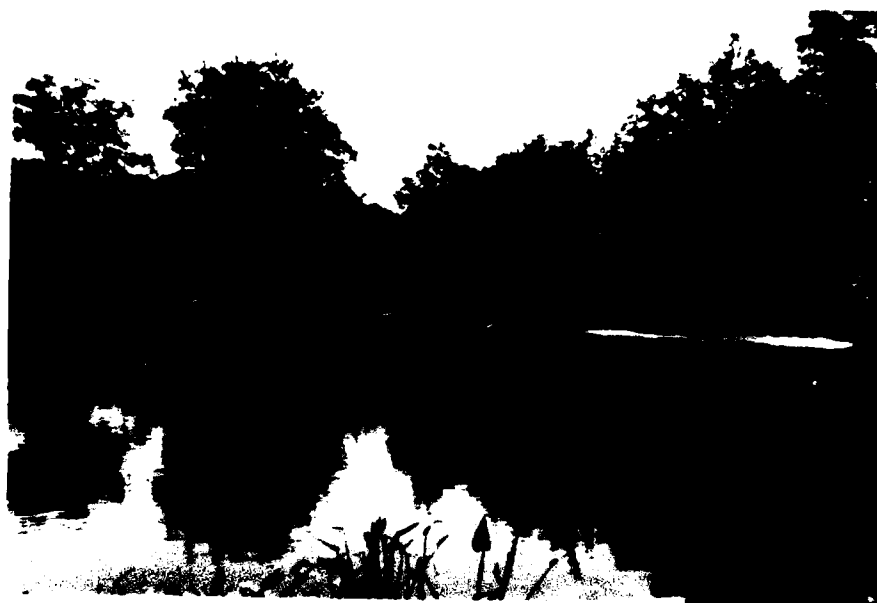
VIEW OF UPSTREAM FACE OF DAM

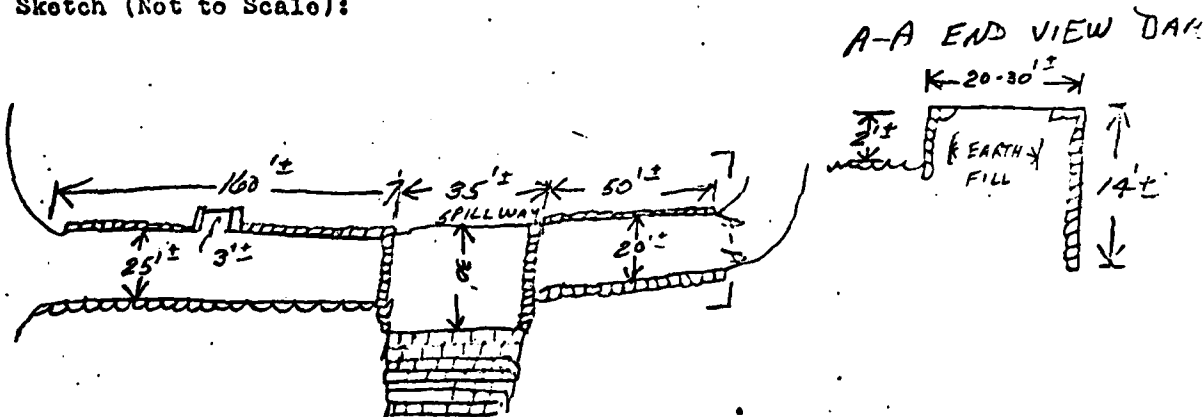
STONE MASONRY WALLS W/ EARTH FILL
3 GATE OPEN CANNOT SEE ANY BOARDS, WATER 1'±
BELOW GOING OVER SPILLWAY. SPILLWAY WALLS 18" ABOVE
SPILLWAY.
Sketch (Not to Scale):

STONE MASONRY WALLS FACING THE WATER HAVE
BEEN REMOVED IN NUMEROUS SPOTS CAUSING
DEPRESSIONS IN DAM FACE FROM 1'-2'± IN SPOTS,
NO APPARENT DANGER.
